Six Chuter Inc.  
**SAFETY DIRECTIVE**  
SB 2007-1

<b>LEVEL</b>	<b>ADVISORY</b>
<b>DATE</b>	Friday, October 05, 2007
<b>SB NUMBER</b>	SB 2007-1
<b>APPLICABLE MODELS &amp; CATEGORIES</b>	SR5 XP <b>Experimental Light Sport Only</b>

1.3.1 This advisory bulletin is issued due to a reported failure of a landing gear strut bolt (AN 4-23) while transporting the powered parachute by trailer.

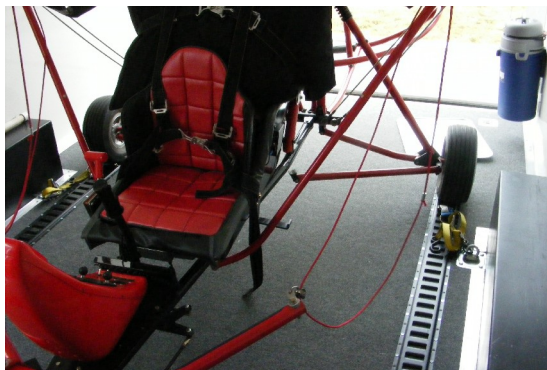
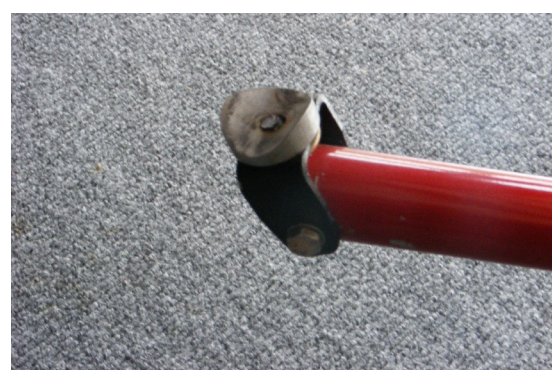
1.4.1 **Description of failure:** Left landing gear strut bolt (AN 4-23) broke at approximately 3/16 inch from the bolt head at the attachment point on the airframe main tube structure. The failure occurred during the transportation of the aircraft and not during aircraft operations. This aircraft was retrofitted with shock absorbing suspension system marketed by Sixchuter Inc. ***There are no other known or reported incidents***

This bolt is one of many bolts that were placed approximately two years ago during the rebuild of the airframe. During the rebuild, the AN4 bolts were tightened to 100 in. lbs. of torque.

- 1) Inferior Materials – Low quality AN bolt. **Note this bolt was not purchased from the factory; rather it was purchased by the builder from an unknown source.**
- 2) Excessive stress introduced through transportation methods. **Excessive side loads are possible on this component depending on how the aircraft is secured to the trailer.**
- 3) Excessive stress introduced through normal operations.
- 4) A combination of all of the above.

- 1.5.3 If the owner discovers signs of stress Six Chuter recommends replacing the bolt with An AN 5 of similar length. Replacing the AN4 bolts with AN5 bolts would yield an estimated 160% increase in Breaking and Yield Strength. The larger diameter bolts also must be equally matched with the attaching brackets and tubing.

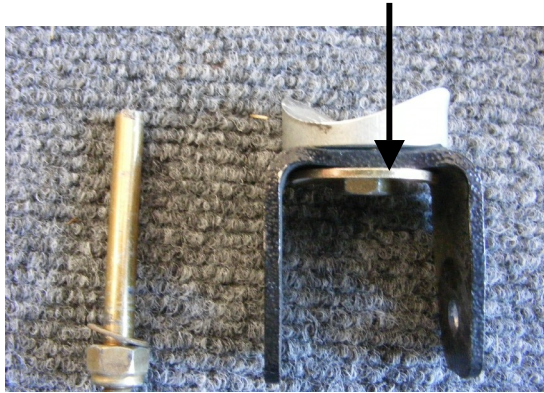
**Note: Bolt Head**

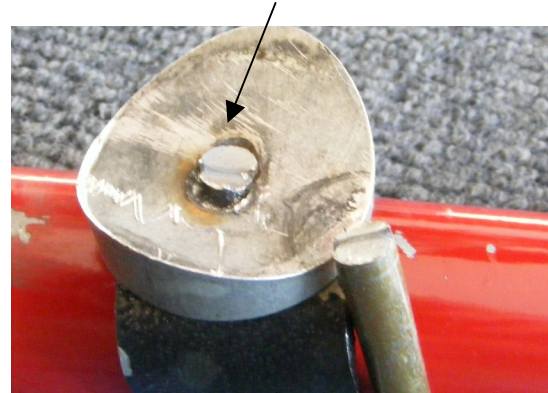
**Note: Ridge in bolt body**

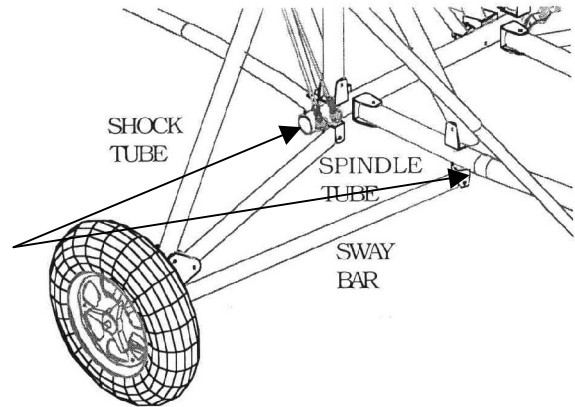
As the landing gear is a critical component of the aircraft, the strength and dependability of these components is essential. The outboard Spindle and Shock Tube assemblies are substantially re-enforced with multiple attachment points. The outboard Sway Bar and inboard Spindle and Sway Bar tubes are attached with a single AN4 bolt (see illustration).
