Six Chuter Inc.  
**SAFETY DIRECTIVE**

<b>LEVEL</b>	<b>MANDATORY</b>
<b>DATE</b>	09/01/2009
<b>SB NUMBER</b>	SD 2009-01
<b>APPLICABLE MODELS &amp; CATEGORIES</b>	Legend XL Beginning Serial Numbers 3049

- 1.0 Planning Information
  - 1.1 Aircraft Affected
    - 1.1.1 Problem was noted on Legend XL 3091 and 3094. No other reports with this issue have been reported on any model
  - 1.2 Concurrent Bulletins
    - 1.2.1 Service Letter 2009-02 (2010 Outrigger Updates)
  - 1.3 Reason
    - 1.3.1 Stress crack in upper attachment bracket for rear outrigger support tube. Owner during pre-flight noticed stress crack in brackets on both side outriggers. Owner on second unit noted deformity of bracket and broke bolt while in flight. It was determined that on affected units the brackets were 1 ¼" 14 Gauge. The maintenance manual requires this bracket to be 1 ¼" 12 Gauge. It is additionally determined that the support cable tang that is installed under the bracket, can lead to unnecessary stress on this installation.
  - 1.4 Subject
    - 1.4.1 Outrigger support bracket stress crack

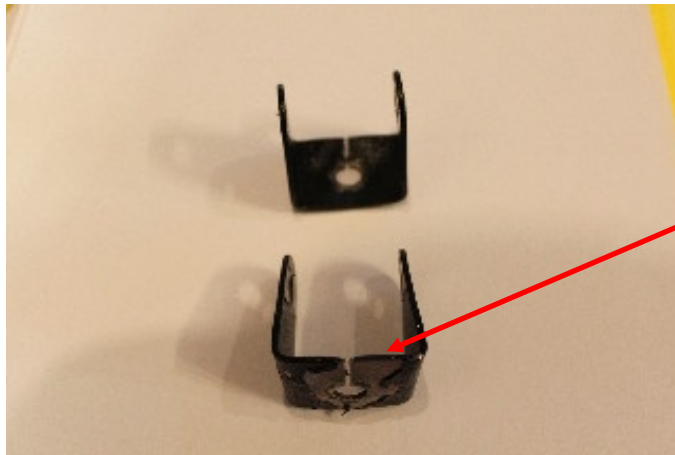
Crack from Bolt to outside edge of bracket

1.5.1.1 Owners who discover any signs of cracking on this component should not fly their aircraft until the crack is repaired by replacing the affected bracket. Six Chuter recommends replacement of these MA 3744 1 ¼" 14 gauge brackets with heavier bracket part number STP 115 1 ¼" U Bracket 12 Gauge

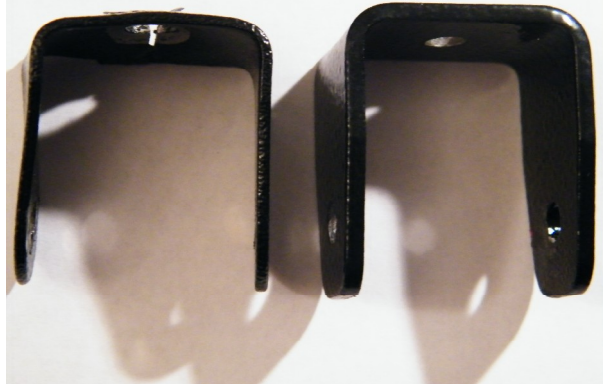
1.5.1 **CORRECT BRACKET** Owners of any Six Chuter with the new outriggers must check for signs of stress on brackets connecting the front and rear support tubes to the outrigger and to the deck. This inspection should determine whether the wrong gauge bracket is installed.

Incorrect 14 Gauge Bracket

Correct 12 Gauge Bracket

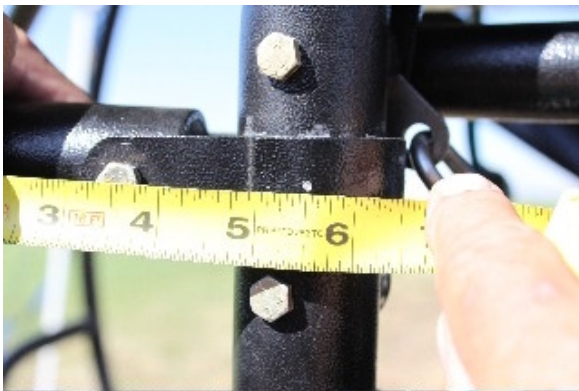
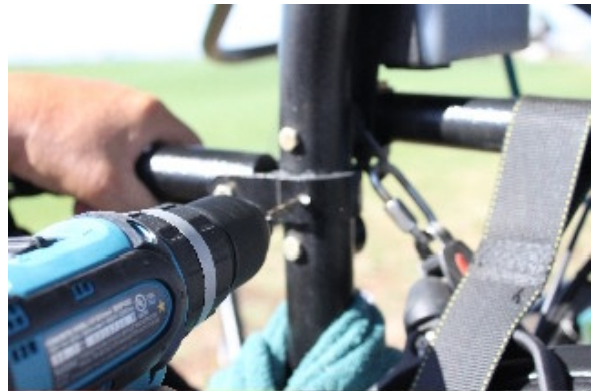
1.5.2 **BOLT PIVOT BRACKET** It has additionally been determined that the outrigger assembly can be strengthened by bolting the pivot bracket to the pylon. On previous models with adjustable c.g. tubes it is important that the pivot bracket remain free. On the 2008 Legends and later with variable c.g. adjuster bracket there is not need for the free movement of the pivot bracket. The current maintenance manual does not call for this but will be updated for 2010. Owners of Legends with this installation should make this modification as follows:

Modification to late model Six Chuter Legend with adjustable hang points instead of adjustable c/g tubes.

The procedure is as follows: Locate and center punch the hole location indicated in photo. (1/2" from the edge of the slight bevel and centered vertically. Mark this location on both sides of the bracket. Drill through one side of the bracket and pylon tube using a 7/32 or smaller drill bit being careful to maintain drill alignment so the drill passes through the center of and perpendicular to the pylon tube. Note: Sharp bits wander off center less than dull ones! Repeat on the opposite side of the pylon tube. **WARNING!!!** Do not attempt to drill all the way through the tube and bracket in a single operation. Maintaining drill alignment is much more difficult. Now, use a 1/4" drill bit to enlarge the hole. After enlarging the hole on one side of the pylon and bracket the drill may be carefully aligned with the 7/32" hole in the opposite side of the tube and the drilling operation completed in a single pass. Install the bolt from the front of the machine and place the nut on the rear. Repeat on other side of the aircraft.

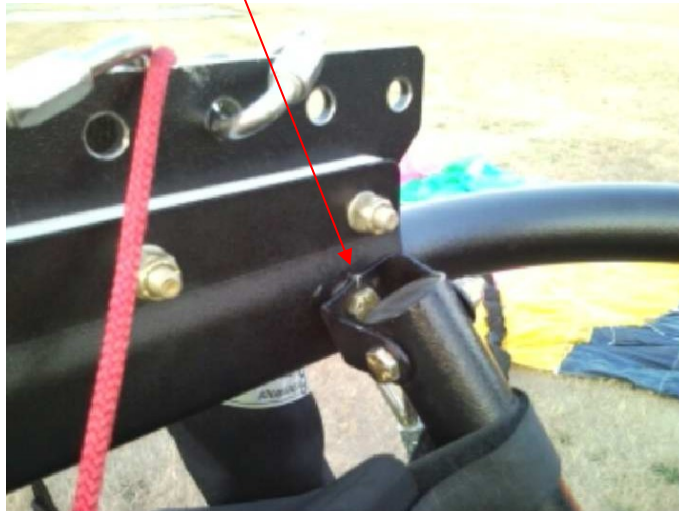
1.5.3 **REPOSITION LOWER CABLE TANG** A final modification should be made to reduce stress on this installation. The current maintenance manual specifies connecting the lower cable to the outrigger by positioning the tang **between** the support tube bracket and the c.g. adjuster bracket. This practice does not allow the bracket to seat against the outrigger bracket.

1.5.3.1 The recommended installation is to change the direction of the bolt insertion and secure the lower cable by positioning the tang between the bolt head and the bracket.

1.5.3.1.1 Insert the outrigger tube inside the outrigger bracket so the corresponding holes in the tube align with the lower holes in the bracket. In the rear hole from the inside: AN4-23A bolt, tang (outrigger cable), 1 1/4" U-bracket 12Gauge, Outrigger Bracket, Outrigger Tube, Outrigger Bracket, AN960-416 washer, AN365-428A nut. Tighten.
