Six Chuter International LLC

SERVICE BULLETIN 2013-02

LEVEL	ADVISORY
DATE	08/01/2013
SB NUMBER	Service Bulletin 2013-02
APPLICABLE MODELS & CATEGORIES	All Legend Models (XL, Paragon, 103s)

1.4) Subject
Inspection, maintenance or replacement of Front Fork Parts

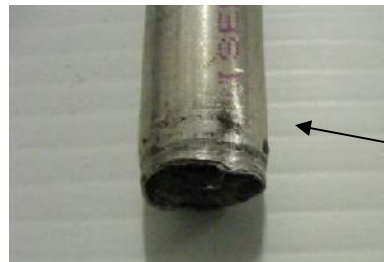
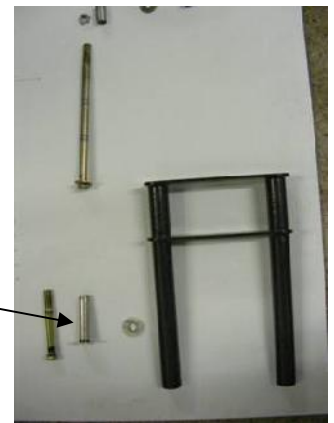
AFFECTED INSTALLATION & PARTS

We have had a total of six reported maintenance issues on Legend XL front forks. These have been on both the heavier fork for 912 and the standard one. The aluminum insert for the bolt that connects the fork to the frame rail has been found to wear excessively. Once worn the bolt tends to enlarge the hole resulting in wobbling movement of the front fork. These reports are from owners of Legend powered parachutes that are flown from rougher fields, or are heavy use aircraft (training) and other high hour uses.

3.1 Order replacement parts, Brass Bushing. Carefully drill out the ¼" hole to accommodate installation of brass bushings on top side and underside of fork. Replace the front fork. Eliminate the aluminum insert and secure the end plate of the frame rail.
