Six Chuter International LLC

SERVICE BULLETIN 2013-02

LEVEL	ADVISORY
DATE	08/01/2013
SB NUMBER	Service Bulletin 2013-02
APPLICABLE MODELS & CATEGORIES	All Legend Models (XL, Paragon, 103s)

1.4) Subject
Inspection, maintenance or replacement of Front Fork Parts

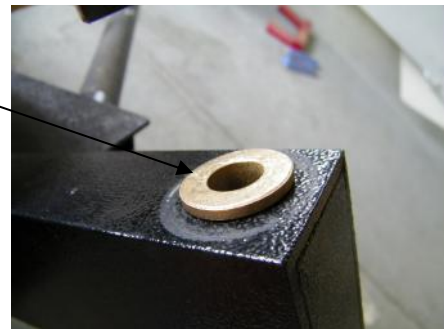
We have had a total of six reported maintenance issues on Legend XL front forks. These have been on both the heavier fork for 912 and the standard one. The aluminum insert for the bolt that connects the fork to the frame rail has been found to wear excessively. Once worn the bolt tends to enlarge the hole resulting in wobbling movement of the front fork. These reports are from owners of Legend powered parachutes that are flown from rougher fields, or are heavy use aircraft (training) and other high hour uses.

1.5.3 If there is any deformation to the aluminum insert, or if the holes that hold the front fork bolt are showing signs of deformity, then this new installation is recommended.

3.1 Order replacement parts, Brass Bushing. Carefully drill out the ¼" hole to accommodate installation of brass bushings on top side and underside of fork. Replace the front fork. Eliminate the aluminum insert and secure the end plate of the frame rail.
