Six Chuter Inc.  
**SAFETY DIRECTIVE**

<b>LEVEL</b>	<b>MANDATORY</b>
<b>DATE</b>	09/01/2014
<b>SB NUMBER</b>	SD 2014-02
<b>APPLICABLE MODELS &amp; CATEGORIES</b>	All models and years with two stroke engines using poly Oil Reservoir or four stroke engines with poly Coolant Reservoir

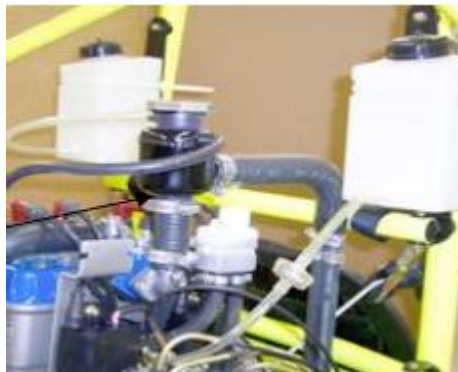
4.1 In one case an owner installed an older style, non-vented plastic cap on a new style oil reservoir. The lack of vent restricted oil flow to the engine, resulting in an engine failure. The older style caps on older style reservoirs illustrated below come from the vendor without a vent hole. When used on the plastic gas tanks they remain unvented and a vent tube is installed on the gas tank itself. When used on either the coolant or oil reservoir a 1/8" hole must be drilled in the top of the cap to allow for proper venting. This instruction is in the relevant Six Chuter engine installation manual.

Older style (prior to 2009), Coolant and Oil Reservoirs. Caps have small nipple on top for safety wire

- 5.1 Owner of units produced prior to 2009 with the older style coolant and oil reservoirs must insure that they were installed according to the manual.
- 5.2 These caps, if used on the plastic gas tanks should be non-vented, and a vent hose must be installed on the gas tank, according to the installation manual.
- 5.3 If these caps are used on the coolant and oil reservoir they must be drilled with 1/8" bit on top of the cap to provide for the vent.
- 5.4 The preflight inspection must include regular checking of this cap to insure that it is clean and that the vent hole is unobstructed.

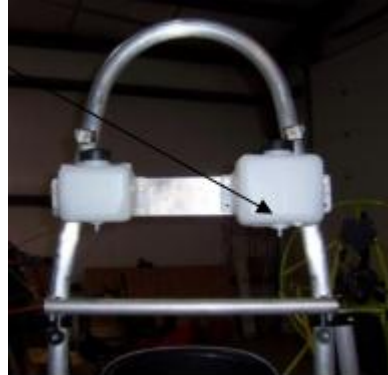
- 4.2 In the second reported incident an owner of an older model installed the newer style oil reservoir. The caps that come from the vendor use a very small hole to vent the cap. In this case the smaller hole can easily be blocked if the cap is not cleaned and checked regularly as part of the preflight inspection. In this case the oil flow became restricted resulting in engine problems.

New Style Oil and Coolant Reservoirs with rounded caps

- 6.1 Owners must check the vent hole as a part of daily preflight to insure cleanliness of the cap and an unobstructed vent hole.
- 6.2 If the cap has the smaller "pin prick" size vent hole, owners are advised to drill that out with 1/8" bit.
- 6.3 A new part is available to replace the caps with smaller vents on the newer style reservoirs. This newer style cap uses an internal cap vent that avoids the need for drilling out the cap and is less prone to obstructions from debris. This cap will be installed on all units beginning with Serial Number 3155.
